Manhole Inspection Summary

Manhole # S27EE_015MH

Insp Date: **7/7/08 9:20 AM**

Location Address: **1506 PENNSYLVANIA AVE** Cross Street: **MCMECHEN ST**

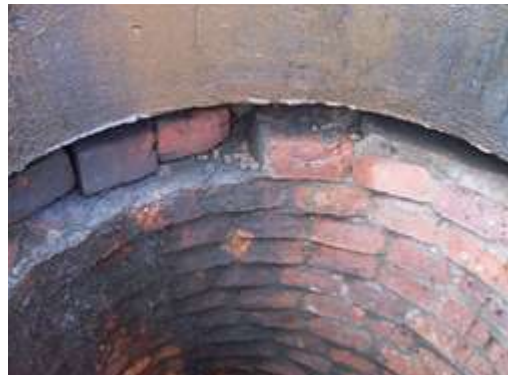
Defect 3

Condition: ☐ Sound ☐ Cracked ☐ Root Intrusion ☒ **Loose Brick** ☐ Deteriorated

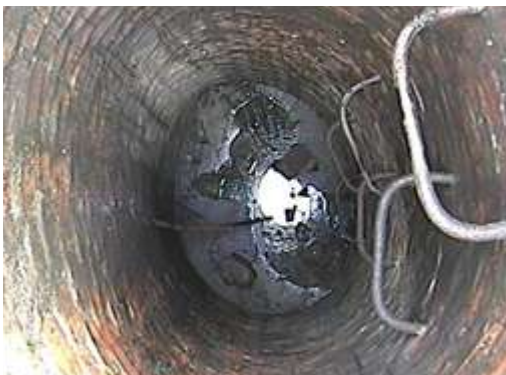
Defect 2

Steps Count: **6** Missing: **0** ☒ **Corroded**

STEPS CORRODED

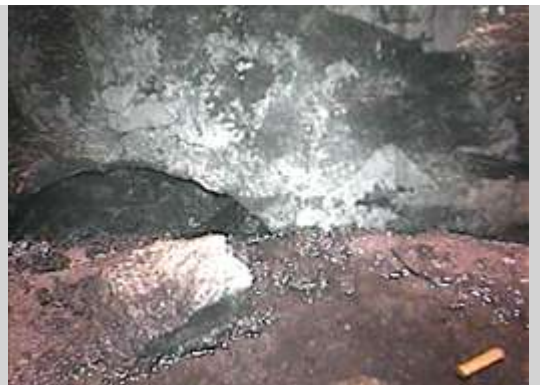
12 O'Clock Outflow

8 in. Circular Gravity Sewer
Pipe Out @ 12 O'Clock

Deposits: ☐ None ☒ **Mud** ☐ Sludge ☐ Debris ☐ Grease

Silt Depth: **5** (in.) Deposits Extent: **Heavy**
